# PROJECT SHORL

STRUCTURAL SURVEY OF PRIVATE MINING PROPERTIES

U.S. BUREAU OF MINES

# STRUCTURAL SURVEY OF PRIVATE MINING PROPERTIES

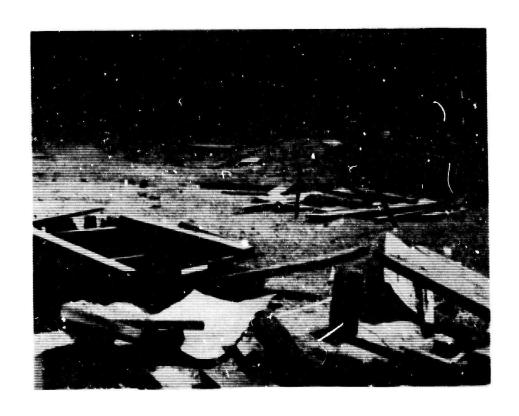
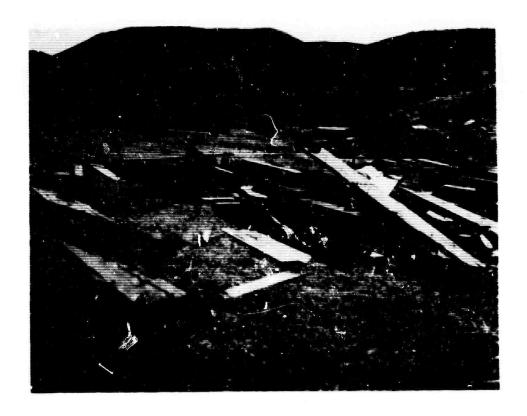
Photo 3-2-10. Preshot. September 30, 1963.

Photo No. 3-2-10. Surface view of inclined shaft on left, main shaft on right. Collars of both shafts are partially dismantled and in a caving condition especially near the surface. A large amount of timber debris covers the surface area.

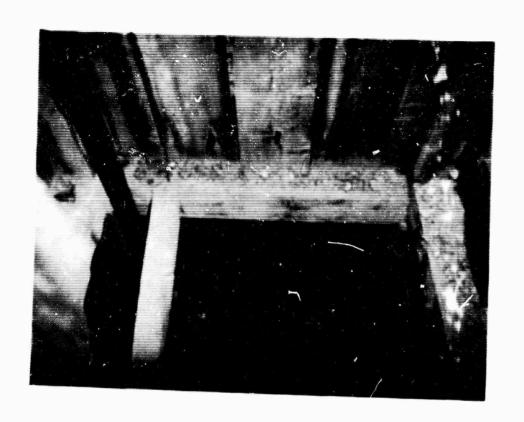
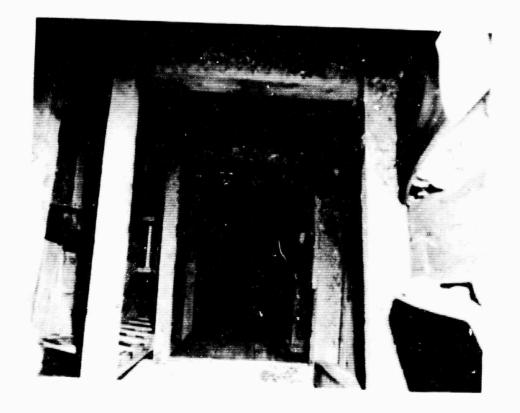
Photo 5-2-19. Preshot. September 30, 1963.

Photo No. 5-2-19. East vertical one compartment shaft. Timbered Amen-sions are 6 x 4 feet. Reported depth is about 400 feet. Some lagging and sets partially caved. Ladderway partially collapsed. No cage guides at collar sets. Shaft collar in caved and weakened condition. Steel hand winch in discepair over shaft.

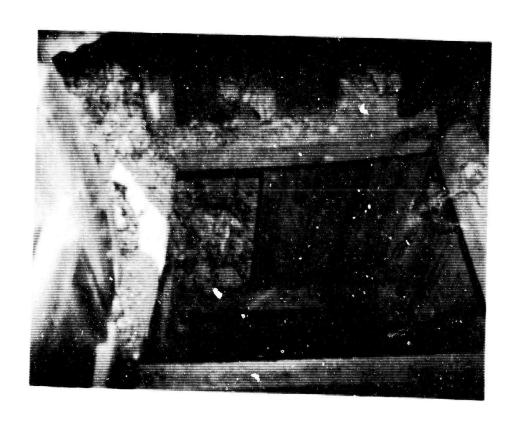
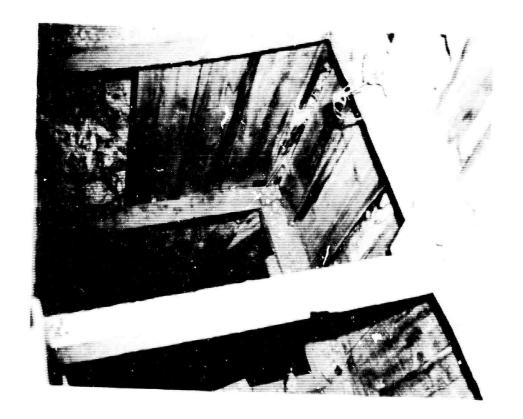
Photo 5-3-20. Preshot. September 30, 1963.

Photo No. 5-3-20. Central vertical shaft. Timbered dimensions are  $7 \times 6$  feet. Other than two timber sets at the shaft collar, the shaft is unsupported. Some lagging from these surface sets is gone while other lagging is in a warped and sprung condition. The shaft is in an incipient caved condition at the surface.

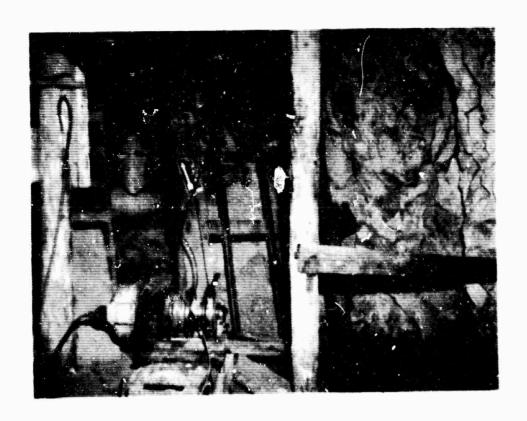
Photo 11-11-54. Preshot. October 2, 1963.

Photo No. 11-11-54. Station for 1000-winze on 400-foot level. Inclination of winze is 72 degrees. Random round 8-inch timbers are used for support. A large amount of mining equipment was found at this winze station.

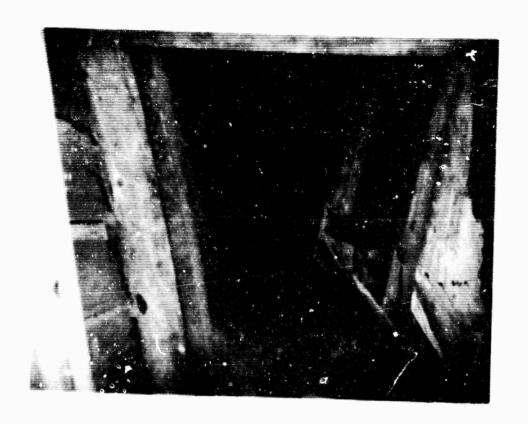
Photo 11-12-55. Preshot, October 2, 1963.

Photo No. 11-12-55. Row of broken 10-inch round timber posts on hanging wall of 74. A stope on 450-foot level. The bearing of this stope is about northeast.

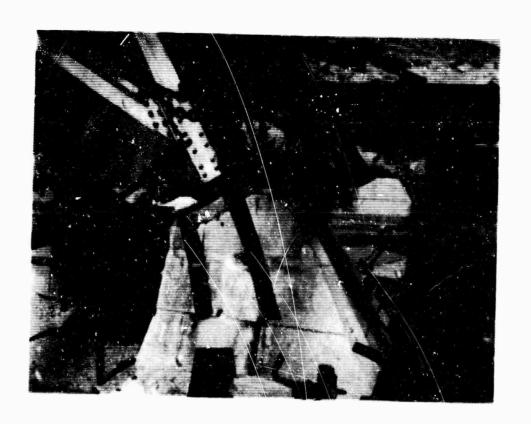
Photo 11-14-57. Preshot. October 2, 1963.

Photo No. 11-14-57. Subsidence by undermining from the 250 stope has caused separation between the steel leg and concrete pier of left rear post of headframe. Reference mark measured 6.05 inches separation both pre- and postshot. The  $1/4 \times 3$ -inch steel straps holding the headframe leg to the concrete pier do not form a rigid connection and the steel straps can be deflected by hand pressure.

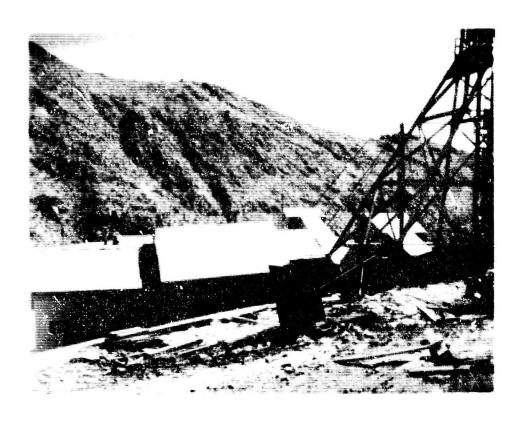
Photo 11-15-58. Preshot. October 2, 1963.

Photo No. 11-15-58. Subsidence by undermining from the 250 stope has caused a four degree northward tilt to hoist house. The concrete foundation for the hoisting equipment has a large crosswise crack immediately behind the main drum. The hoist consists of a cylindrical double drum electric powered system mounted on a steel frame.

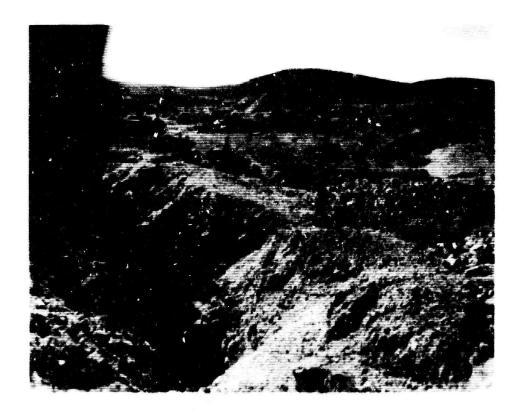
Photo 14-1-66. Preshot. October 3, 1963.

Photo No. 14-1-66. Nearly vertical open stope mined to the surface immediately to the south of the main shaft. Irregular width 3 to 8 feet, and 100 feet or more in length and depth. The trailer in the center background lies near the edge of the open stope. The trailer burned down from unknown causes on October 19, 1963.
